Multicopter Aerial Photo Survey of Building Damages by 2013 Bohol Earthquake in the Philippines

INOUE, Hiroshi^{1*} ; HANAZATO, Toshikazu² ; IMAI, Hiroshi¹ ; MELOSANTOS, Arnold³ ; ALCONES, Ponzch³ ; SORIANO, Karl vincent³

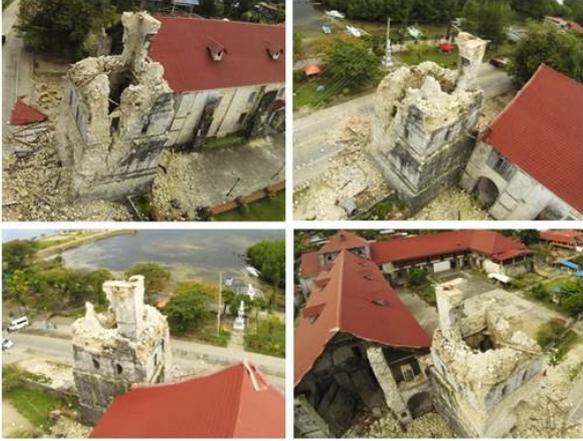
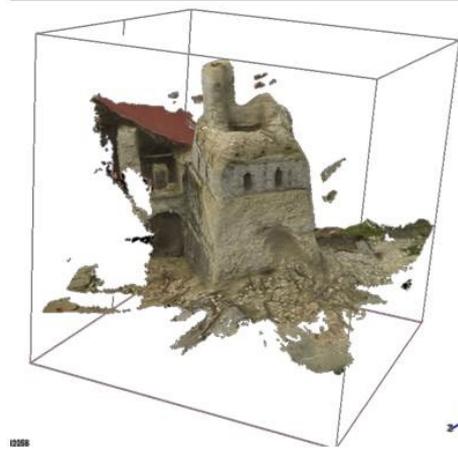
A number of stone masonry churches founded in the 16th century in the Spanish colony times were damaged by the earthquake. The existing building of Baclayon Church, which was constructed in 1727 and known as the oldest church in the Philippines, lost the upper half of the bell tower and the whole front wall of the cathedral. Loboc Church and the adjoined museum in the Loboc city lost most of the side walls except their lower part. Maribojoc Church in the west and Clarin Church in the north of the island collapsed completely. Notable damages are also on non-structural masonry walls confined by RC columns and beams of public buildings, such as Sagbayan city hall and Tubigon city hall.

The left figure shows the multicopter aerial photos of the damaged Baclayon Church. We can observe the fracture surfaces of the upper structure and its inside which are invisible from the ground. Aerial photographing using multicopter right after an earthquake is an efficient tool to easily get full picture of the damage even when approaching from the ground around a building is difficult. We then processed about 50 aerial photos using an SfM (Structure from Motion) software PhotoScan to reconstruct the 3-D model of the bell tower as shown in the right figure. The techniques enable modeling fractures of buildings and their analyses. The 3-D models are also valuable as digital architectural remains of disasters. Aerial photogrammetry using multicopter and SfM is easier than 3-D measurement using laser scanner. Creating a miniature of damaged building from the digital model using 3-D printer will also be useful for planning repairs and earthquake resistant design of buildings.
