Slope failures caused by heavy rain and volcanic activity: a case study around Esan volcano, in Hokkaido

Satoshi Ishimaru^{1*}, Jun Tajika¹, Makoto Tamura¹, Hajime Sato²

¹Geological Survey of Hokkaido, ²Hokkaido Forestry Research Institute

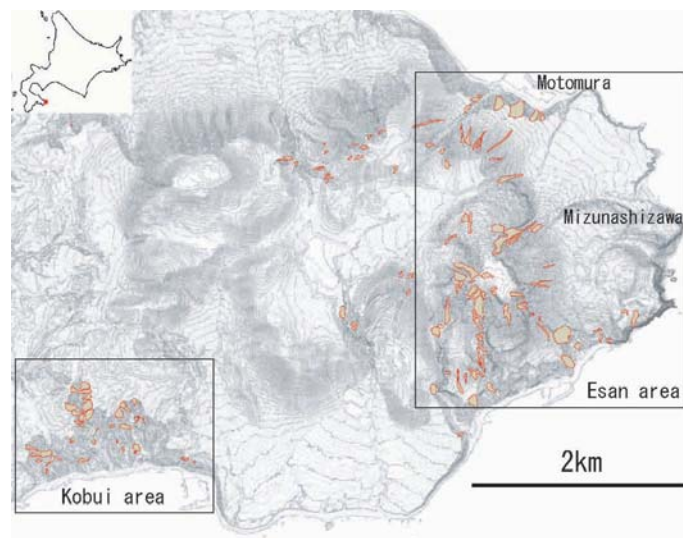
concentrate in Esan area and Kobui area (see the above map), which are the upper area of the debris flows, by aerial photos. Because alluvial cones develop the mouth of these valleys in both areas, raised bed rivers stand side by side along the coastline.

The volcanic ash of 1846 eruption spread east of Esan. Slope failures occurred in Esan area, because surface stream on the volcanic ash with low permeability concentrated in valleys in heavy rain. Mizunashizawa collapse is the greatest in these slope failures. The collapse discharged the lobes of debris flows. One of them flowed to the upper Motomura River. Though the debris flow deposit is not distributed in Motomura village, located at the mouth of the river, this village is most heavily damaged in this disaster. Therefore, flash flood with low-density sediments would strike this village. In the other hand, because the volcanic ash of 1846 eruption is not distributed in Kobui area, the cause of the slope failures is not the volcanic ash. The slope failures occurred from marine sand gravel layer to Es-P3, pyroclastic flow deposit, distributed in this area. Es-P3 is cap rock of the sand gravel layers. Because Es-P3 is low permeability, surface stream predominates and erosion activity is strong along valleys by heavy rain in Kobui area.
