## A study related to stability for the earthen archaeological site in central Asia

Yukiyasu Fujii<sup>1</sup>, WATANABE Kunio<sup>2</sup>, Enrico Fodde<sup>3</sup>

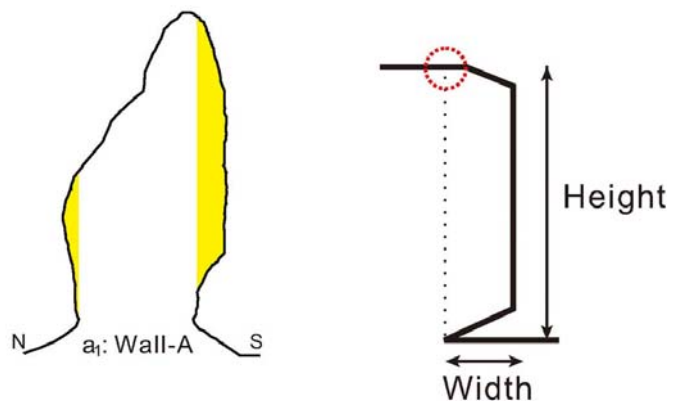
Left figure shows the section of pre-collapse structure. The basal part of structure was eroded, and it was similar to the overhanging cliff. Therefore, it can be assumed as the cantilever deformation with its own load (right figure). On the top of the structure, the maximum tensile stress can be calculated as  $T_x = 3W^2pg/H$ , in which  $H$  is the height of structure,  $W$  is the depth of erosion,  $p$  is density of mud brick, and  $g$  is gravity. According to the observation on fracture surfaces, the fracture started as tensile, and proceeded to shear fracture.

It can be inferred that the main causes of collapse are following three phenomena. First, the basal part of the structure was eroded and  $W$  reached the finite length. For an example of left figure with assumption of  $p = 2.2\text{kg/m}^3$ ,  $T_x$  can be calculated as about  $10\text{kN/m}^2$ . This value is much lower than the strength of mud brick in dry situation. However, the strength of mud brick decreases with

increasing moisture in it. Therefore, it will be possible to collapse in the winter rainy season in Tajikistan. Second is crack proceeding from the top of structure. Progress development of crack decreases  $H$  in the above equation, and  $T_x$  will increase to the strength of mud brick. In addition, intrusion of rain water into crack might cause the weakening the crack -tip. Third Phenomena might be earthquake. There are many earthquakes in Tajikistan, which is located west of the Pamir Mountains. During earthquake, gravity might be twice or more than ordinary one. It will be the trigger for collapse.
