Detailed Survey on the Earthquake Resistance of Backbone Buildings in Padang after the September 30 Pariaman Earthquake

Mulyo Harris Pradono^{1*}, Yozo Goto², Akio Hayashi³, Kazuhiro Miyatake³, Rusnardi Rahmat⁴

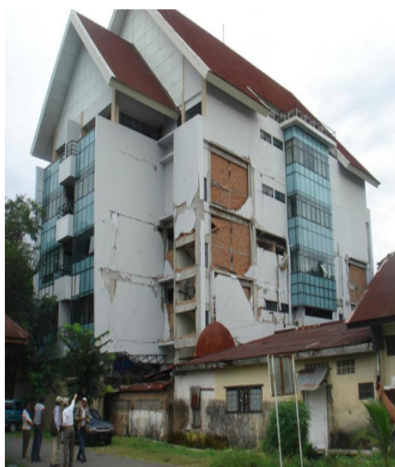
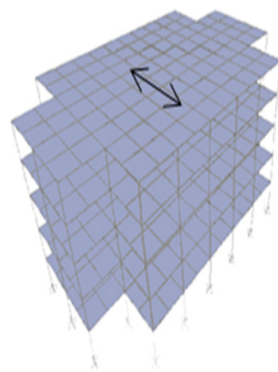
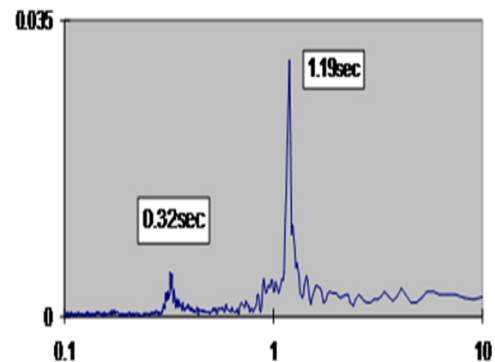
3-D frame model and microtremor measurement of the surveyed building

3-D frame models of the three buildings were defined and the models were checked through the comparisons of the natural frequency with the measured natural frequency by the micro-tremor observation on the buildings. The response stresses due to the estimated earthquake intensity were computed and compared with the column strength, and the consequent damages were discussed. The failure mechanism was postulated so that future failure should be avoided by proper retrofit or reconstruction.
