MIS036-P163

## Ground Damage on Man-made Land caused by Mega Earthquake -Characteristics of Ground Disaster due to the Quake-

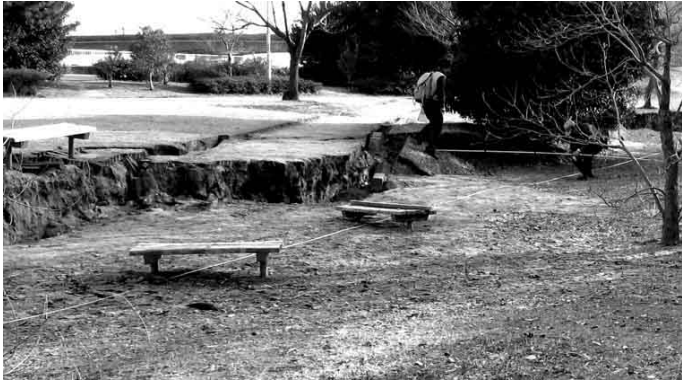
Photo: Fault (approximately 190m in length and approximately 70cm in throw; open sense) in liquefied zone at Hamigawa-ryokuchi, 3 Utase Mihama-ku Chiba city, Chiba pref.
