2008年岩手・宮城内陸地震による急傾斜地の崩壊の地形・地質環境

Geomorphological and geological environment of the landslides on steep slopes induced by the 2008 Iwate-Miyagi Inland Earthquake

大丸 裕武 [1]; 村上 亘 [2]

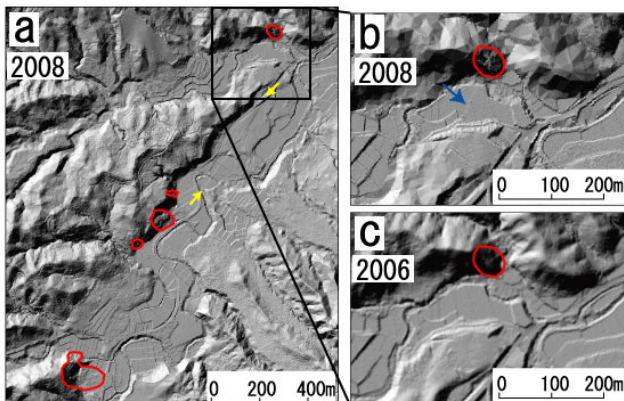
また、岩手県側の山地では、崩壊地が直線上に並ぶ例が多く見られた。図は一関市はの木立地区の例で、リニアメントと平行に直線上に配列する崩壊地が見られる。リニアメントの一部は、地震によって変位が進んだと思われるものや、2006年のDEMでは検出出来ないものもあることから、地表断層によって示される山体内部の変形が崩壊発生に関与したと考えられる。

Fig. LiDAR shade image of the hanokidachi area before (b) and after the earthquake (a, c) in Hanokidachi district, Iwate Prefecture, showing a row of newly occurred landslides (red polygons) parallel to the fault line (between the yellow arrows in fig. a). The northernmost landslide locates on the newly appeared lineament (the blue arrow in fig. b) that were not recognizable in the 2006 LiDAR shade image (fig. c).
