## Mapping active faults by using small unmanned aerial vehicle and structure from motion: a case study on Midori fault

## Multicopter Aerial Photo Survey of Building Damages by 2013 Bohol Earthquake in the Philippines

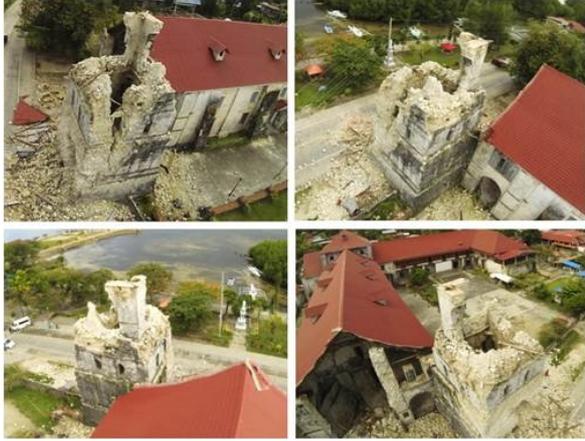
A number of stone masonry churches founded in the 16th century in the Spanish colony times were damaged by the earthquake. The existing building of Baclayon Church, which was constructed in 1727 and known as the oldest church in the Philippines, lost the upper half of the bell tower and the whole front wall of the cathedral. Loboc Church and the adjoined museum in the Loboc city lost most of the side walls except their lower part. Maribojoc Church in the west and Clarin Church in the north of the island collapsed completely. Notable damages are also on non-structural masonry walls confined by RC columns and beams of public buildings, such as Sagbayan city hall and Tubigon city hall.

The left figure shows the multicopter aerial photos of the damaged Baclayon Church. We can observe the fracture surfaces of the upper structure and its inside which are invisible from the ground. Aerial photographing using multicopter right after an earthquake is an efficient tool to easily get full picture of the damage even when approaching from the ground around a building is difficult. We then processed about 50 aerial photos using an SfM (Structure from Motion) software PhotoScan to reconstruct the 3-D model of the bell tower as shown in the right figure. The techniques enable modeling fractures of buildings and their analyses. The 3-D models are also valuable as digital architectural remains of disasters. Aerial photogrammetry using multicopter and SfM is easier than 3-D measurement using laser scanner. Creating a miniature of damaged building from the digital model using 3-D printer will also be useful for planning repairs and earthquake resistant design of buildings.
