Coastline Change and Tsunami Inundation Area of Northern Sumatra Island Inferred from Satellite Synthetic Aperture Radar Images

Mikio Tobita[1]; Masaru Kaidzu[1]; Makoto Murakami[2]; Masaharu Tsuzawa[1]; Tetsuro Imakiire[1]; Hiroshi Yurai[1]; Hisashi Suito[1]; Yoshihiro Fukuzaki[1]; Min Kato[3]; Satoshi Fujiwara[1]; Akifusa Itabashi[4]; Hiroyuki Nakai[1]

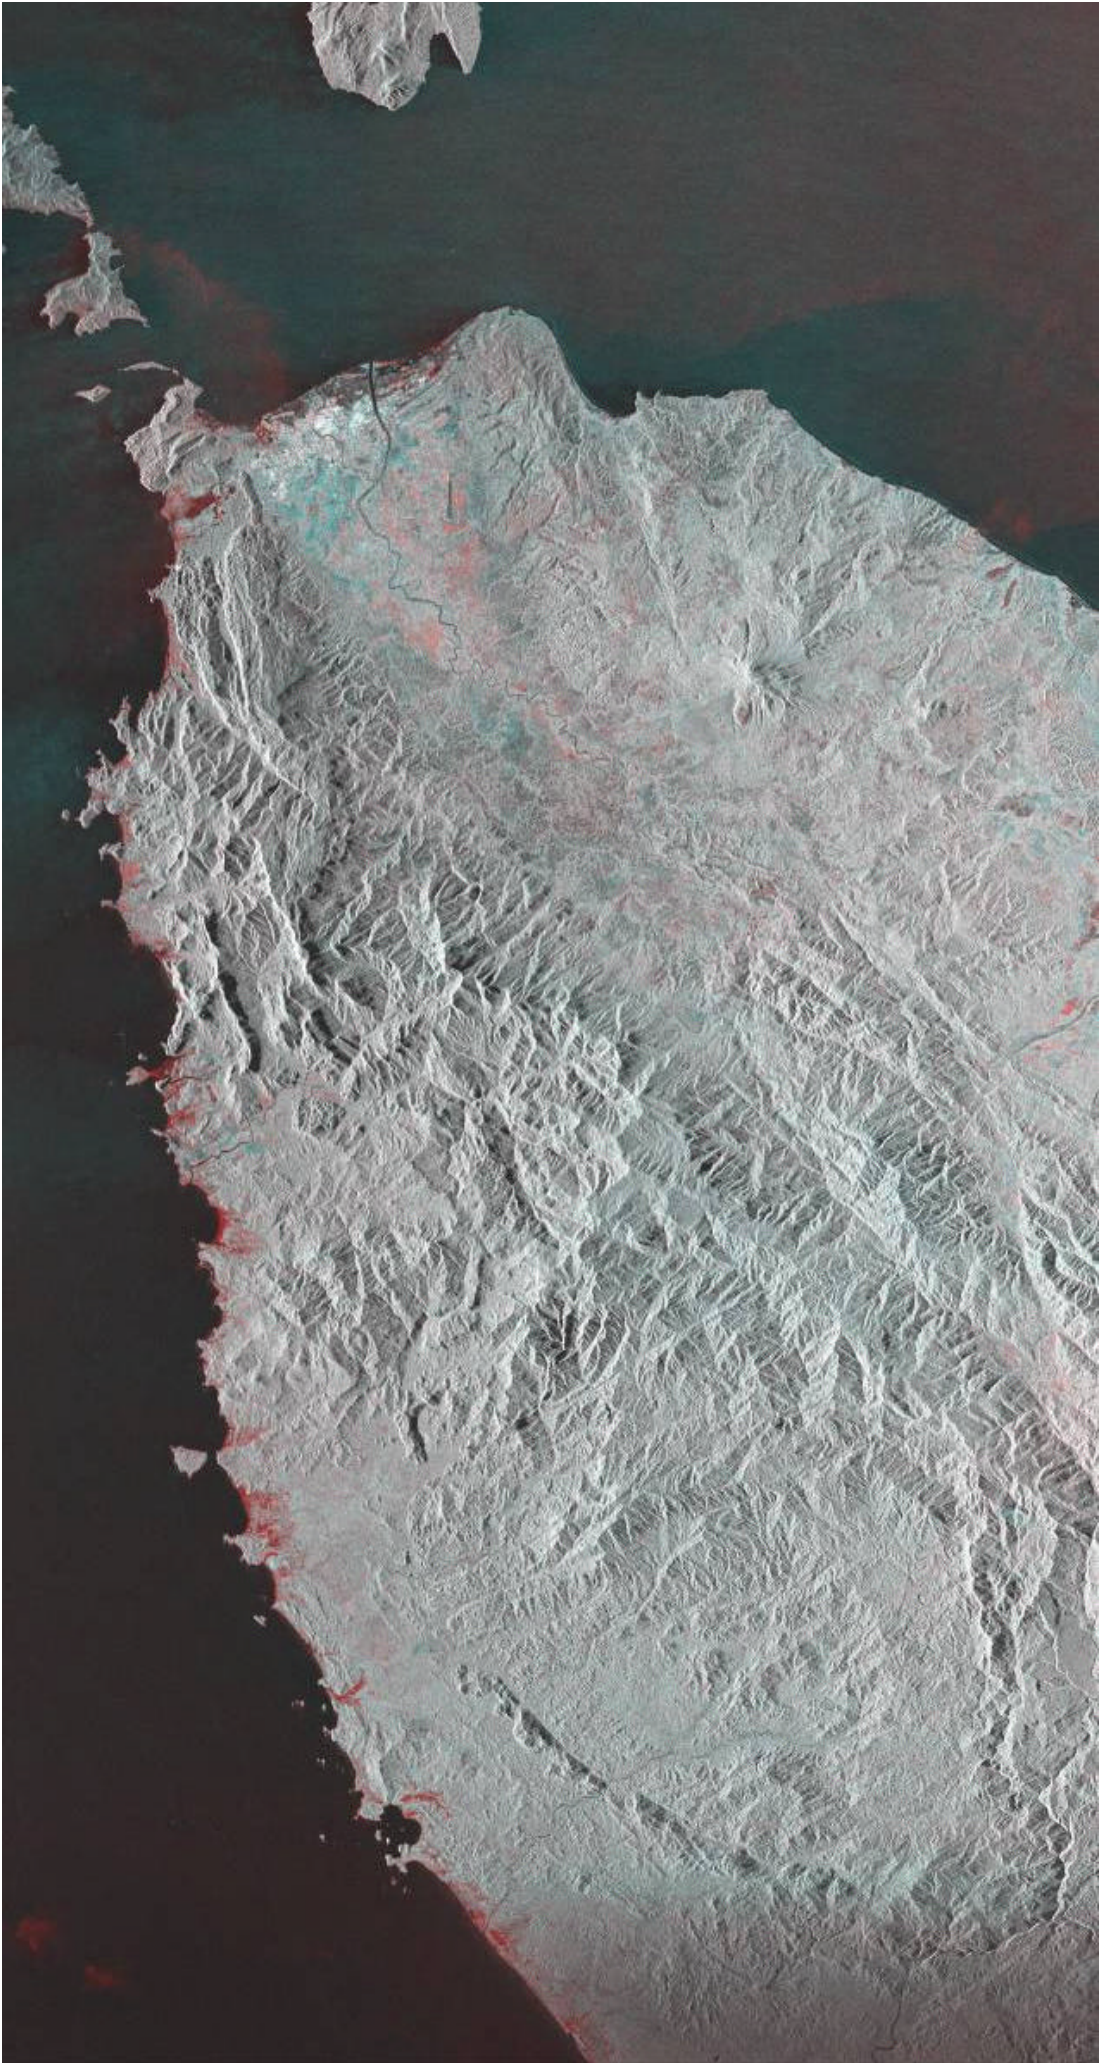
2004 Indian Ocean Earthquake and Tsunami affected coastline of northern Sumatra island. An image was derived from a comparison of intensity of reflected microwave observed by Canadian RADARSAT satellite between July 22, 2003 (before Earthquake) and December 31, 2004 (after Earthquake). An area colored in red is a region where the reflective intensity is decreased. The red areas are distributed along the west coast of northern part of Sumatra Island, Indonesia. The image indicates Tsunami inundation area, coastal erosion and a subsidence caused by a crustal deformation due to the M9 earthquake.
