A cluster of sinkhole scars and sinkhole outcrops in Onikobe caldera

Shuichi Hashimoto[1]

[1] Civil &Architec. Dept.,Tohoku Epco

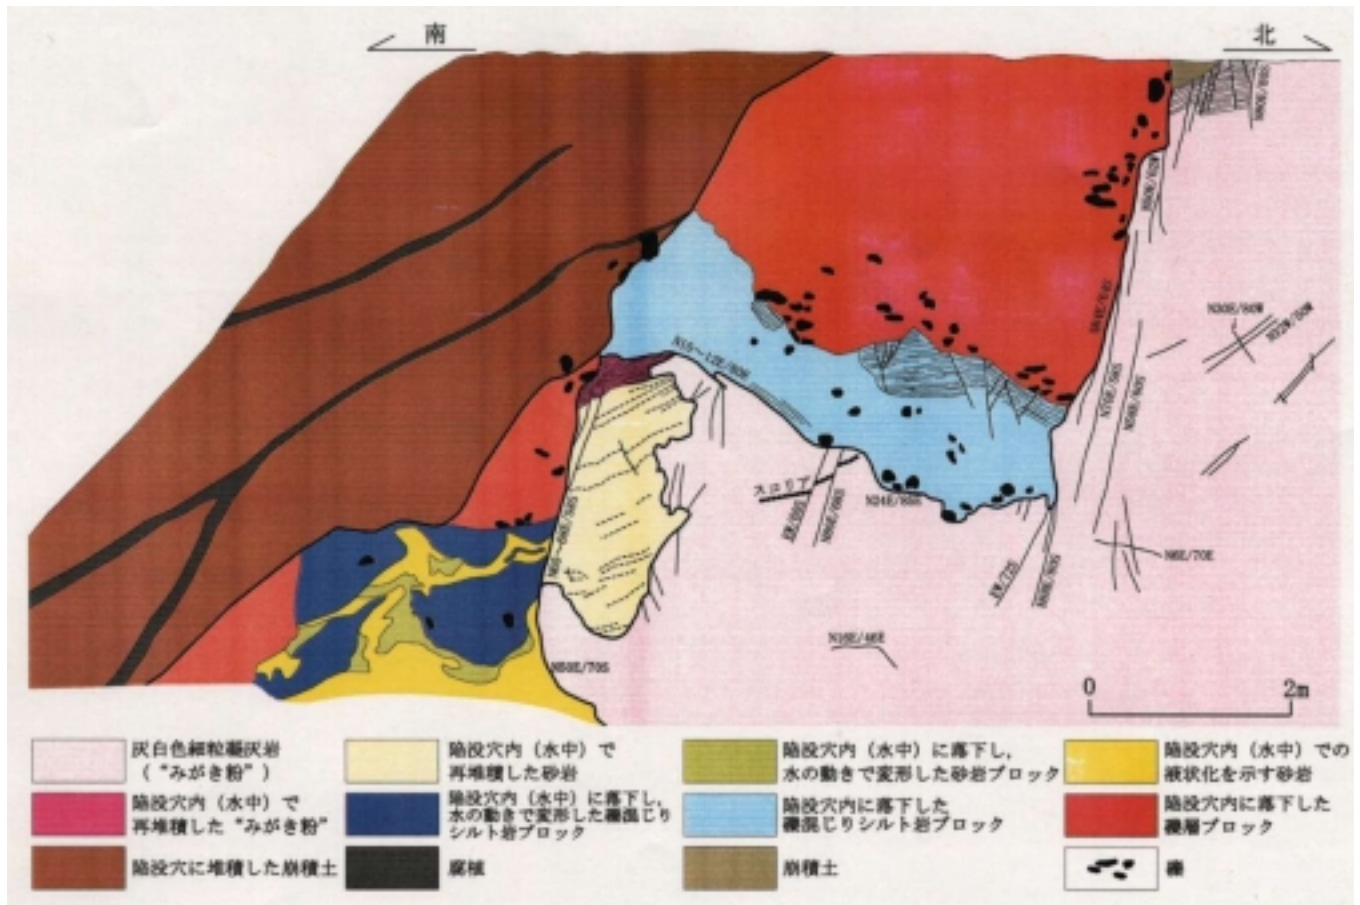
The road-cut exposure contains poorly stratified grayish white fine tuffs(A), laminated sands(B), liquefied sands with silt blocks(C), blocky silts with gravels(D) and gravels(E). The sketch of the outcrop is shown in the attached figure. The color of each layer is as follows: (A); pink color, (B); pale yellow color, (C); yellow and blue color, (D); light blue color and (E); reddish brown color.

The stratigraphic position of fine tuffs(A) , used as polishing powder because of much content of volcanic glass, may be assigned to Pleistocene Miyazawa formation. (D)and(E) are colluvial deposits.

(A) are cut by many minor faults, trending NNE-SSW and ENE, which are dominant in Onikobe area.

(C) and (E) are bounded to the north by ENE trending fault.

(D) and (E) are also bounded to the north by ENE trending fault and to the east by NNE trending fault. These fault planes are very sharp.

These field observations indicate that sinkhole phenomena had repeatedly occurred at this outcrop.
