## Upslope catchment assessment for gully headcut retreat: case study in Kendu escarpment, Kenya.

# Yusuke Katsurada[1]; Mitsuo Hoshino[2]; Koshi Yamamoto[3]; Hidekazu Yoshida[4]; Kenichiro Sugitani[5]

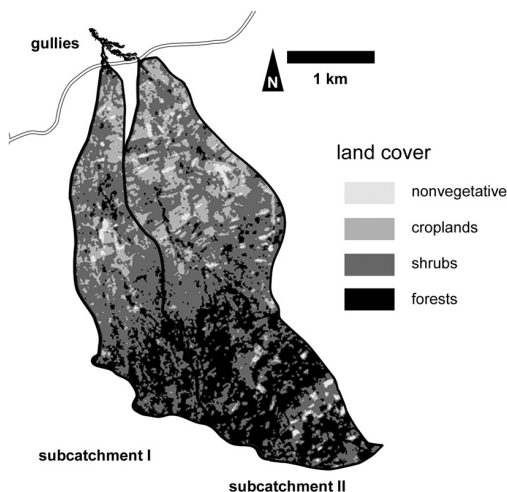
Figure: Land cover map of the upslope catchments. Land covers are classified using NDVI values.
