## Study on slope failure along thin sand layer as slip surface by the 2004 Niigata-ken Chuetsu Earthquake

# Hiroshi Kameya[1]; tetsuo kanai[2]; Jianliang Deng[3]; Yukika Tsutsumi[4]; Junichi Koseki[5]

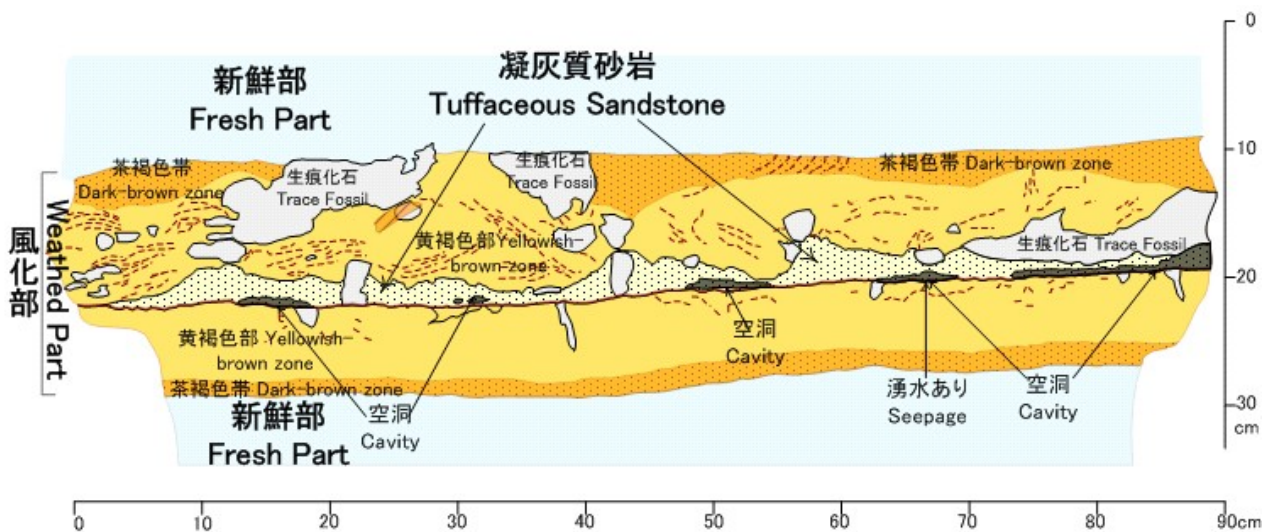
2004 Niigata-ken Chuetsu Earthquake triggered many landslides in the sedimentary rock area. It is pointed out that a fair number of the landslides included the slide-planes which were parallel to the bedding-plane or consisted of the weak thin-layer of the stratum. As these types of landslides often exist in the Green Tuff region in the Tohoku district in Japan, these landslides can be treated as the typical hazard pattern in this area. Among these landslides, the rock slides which do not exhibit clear surface topography must be predicted by the underground structure. The authors investigated the landslide which occurred in Yokowatari-area of Oziya city by the site-investigation, sampling and laboratory test. Thin weak tuffaceous sandstone layer (form 1 to 3cm width) distributed as the slip surface of the land-slide. The authors made an outcrop on the base of the side-wall of the slide area, sketched the geology of the outcrop and cut out the block-samples included the tuffaceous sandstone layer. The figure shows the geology around the tuffaceous sandstone layer. The characteristics of this layer are as follows,

- a. the thickness is not uniform.
- b. weak and weathered
- c. there are many cavities which are assumed as the water-flow pass.
- d. the under surface of the taffaceous sandstone is relatively smooth and it is estimated that the slide occurred along this under surface.
