Estimation of subsurface structure in Anamizu, Ishikawa pref. using micro-tremor records

Ryo Shimizu[1]; Toshiro Maeda[2]

[1] ex. Dept. of Architecture, Waseda Univ.; [2] Dept. of Architecture, Waseda Univ

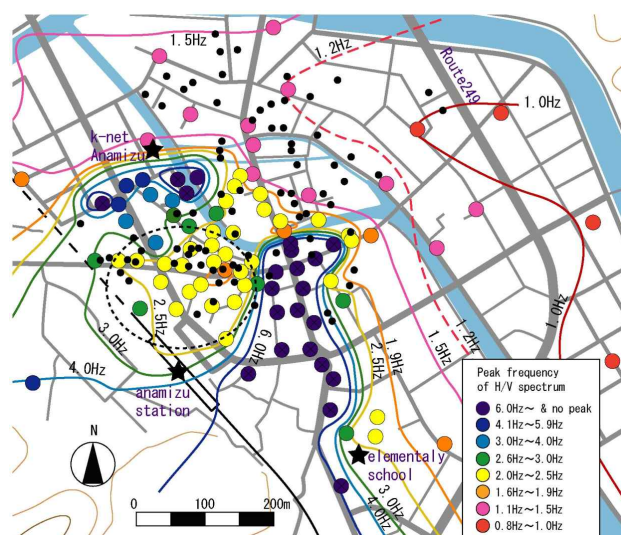
Micro-tremor observation was carried out in Aug. 2007 and Sep. 2008 to capture the characteristics of the subsurface structure in Anamizu. The observation system was composed of portable seismographs (GPL by Akashi), servo-type accelerometers (LS-10C by Rion), and data loggers (DA-20 by Rion). Three component acceleration records of 15 minutes were recorded, where 15 seconds of stationary portions were extracted as samples, and about 10 samples were used to obtain H/V spectra. The H/V spectrum is calculated by an ensemble average of spectral ratio of the horizontal spectrum to the vertical spectrum; the horizontal spectrum is a root of the square sum of two directional horizontal spectra. The figure shows distribution of peak frequency of H/V spectrum and its contour lines.

Peak frequencies of around 0.8 Hz at the south-east side of the town are the lowest; those of 1 Hz to 1.5 Hz at the north-east and the north side of the town are the second lowest. Peak frequencies around ISK005 are 1.5 Hz, which is in accordance with the peak frequency of horizontal to vertical ratio of the particle motion trajectory of the Rayleigh wave fundamental mode based on the PS logging data. The area of about 100 m away from ISK005 at the south and the area west to the Anamizu railway station show peak frequencies above 4 Hz. The central area of the figure shows peak frequency around 10 Hz or no peak. The peak frequencies have large variation in the narrow area of about 500 m square in the figure.

The area indicated in the figure as a circle has almost constant peak frequencies around 2 Hz, whereas the surrounding area except for the north-east direction has higher frequencies with rapid increase at the circumference. Generally, lower peak frequency of H/V spectrum reflects thicker sedimentary layer, which may suggest that the subsurface structure has a sedimentary basin type profile. A number of completely destroyed buildings are found in the circle shown in the figure. One of the reasons of concentrated damage in this area is considered as the amplification of the ground motion due to the topographic effects of the sedimentary basin type profile of the subsurface structure.

The peak ground acceleration of 780 Gal was recorded at the K-net Anamizu station (ISK005) during the 2007 Noto-hanto Earthquake. Though the town of Anamizu is located 20 km away from the epicenter, many wooden structures were damaged by this earthquake. The damaged structures, indicated by black dots in the figure, are irregularly distributed with some concentration along rivers. The PS logging at ISK005 reveals a 16 m thick soft soil layer with Vs of less than 130 m/s, which may affect structural damage in the town of Anamizu.

Peak frequencies of H/V spectra obtained by micro-tremor observation in the town of Anamizu have large spatial variation. One area with almost constant peak frequencies around 2 Hz was suffered from severe damage during the earthquake. Peak frequencies at the circumference of the area are higher and show rapid increase at the edge, which suggests that the damaged area is located at the center of the small sedimentary basin and the concentrated damage may be attributable to its local topographic effects.
