HDS021-06

A large scale Landslide of the accretionary prism in Miyazaki Prefecture

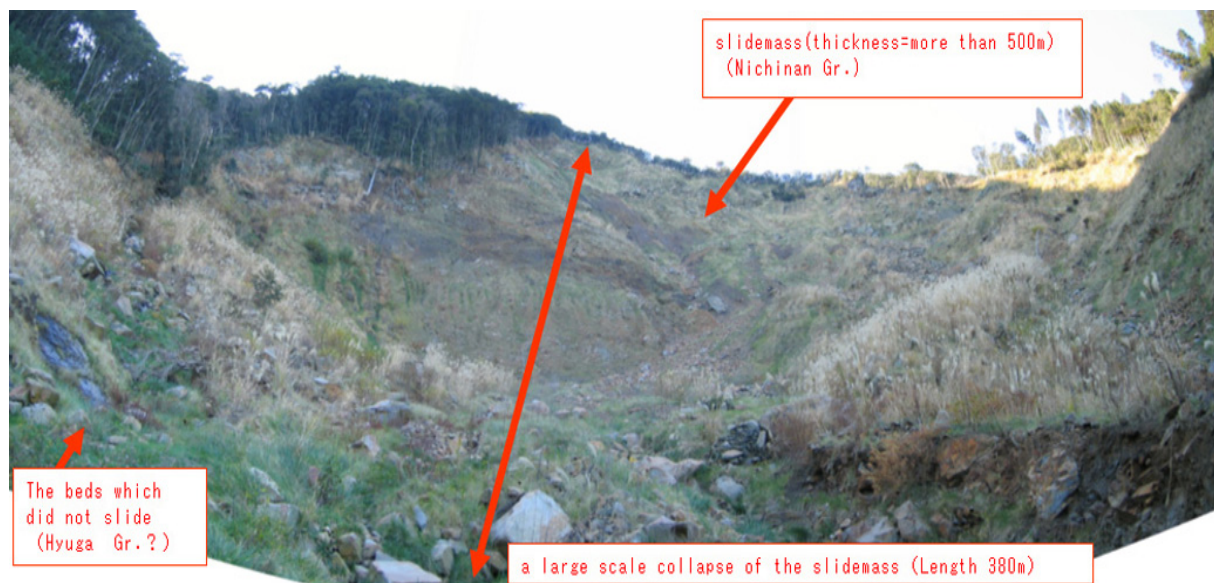
A large scale landslide of Tenjin Mountain in Wanituka Mountain range at central Miyazaki Pref. caused along the boundary of the Hyuga Gr. and Nichinan Gr.

The landslide (the sector collapse) happened on a boundary of Hyuga Gr. and Nichinan Gr. And it is Nichinan Gr. to have had the great collapse (the sector collapse).

This landslide of Nichinan Gr. collapsed by a heavy rain of Typhoon 14 of 2005.

The width of this collapse reaches it than 400m.

We clarified the shape and geological structure of the sector collapse by three-dimensional surveying of the CCD camera.
