Study on the 1707 Hoen Tsunami on the basis of the descriptions in Kokuryoki along the coast of Kochi Prefecture

Yoshinobu Tsuji^{1*}, Kentaro Imai², Yoshikane Murakami³, Fumihiko Imamura²

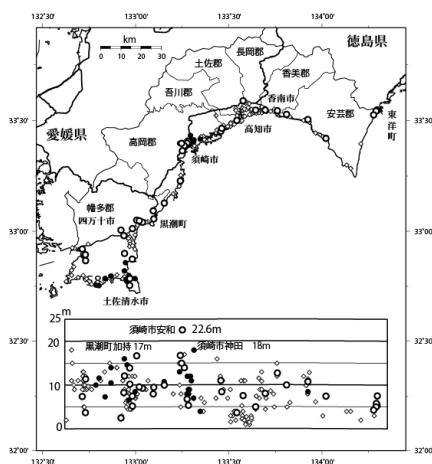
Figure shows the distribution of the inundation heights above the mean sea level for villages. White circles show the villages where heights were measured exactly, Diamonds shows the villages where tsunami heights were estimated by using city planning maps in the scale of 1:2500. Black circles show data given by the previous studies.
