Distribution properties of foundation disaster caused by the Nagano-Niigata border earthquake in 2011

Takayuki Nakano^{1*}, Mamoru Koarai¹, OTOI, Kosei¹, Tomokazu Kobayashi¹

¹GSI of Japan

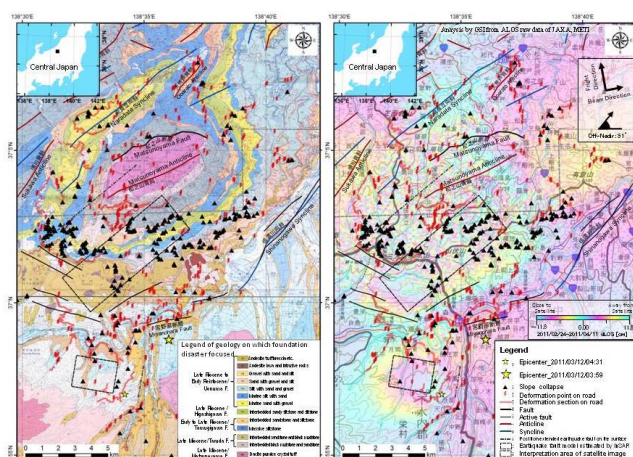
Fig.1 shows overlaying foundation disaster points on geology and geological structure map or InSAR imagery. We identified the properties in addition to the characters reported by Nakano et al. (2012) as follows: 1) A large number of slope collapse occurred in steep slope area consisting of sedimentary rock in Neogene system except landslide area such as Matsunoyama region, 2) A large number of slope collapse and landslide occurred in limb of fold, even if it apart from epicenter (example for the eastside in Mt. Shomenkurayama) in dip slope area, i.e., the occurrence of slope collapse and landslide are tightly related to the geological structure. 3) A lot of ground deformations and cracks, which are almost gravity sliding of road fill, occurred near fold axis and fault line, even if it apart from epicenter.

From the above, we conclude that a foundation disaster caused by a strong inland earthquake in fold zone will occur intensively in the area of hanging wall of the reverse fault with a large amount of crustal deformation, dominated by geology, geological structure such as fold and location of earthquake source fault. This tendency is reported by Koarai et al. (2012) as the example of the Mid Niigata Prefecture Earthquake in 2004, and a fold in this area might develop with the earthquake. (This works was supported by MEXT KAKENHI (22500994))
