南アフリカ金鉱山 M1.5 地震極近傍の応力測定

In-situ stress measurement at the closest proximity of an M1.5 earthquake at Tau Tona gold mine in South Africa

SSS28-P20

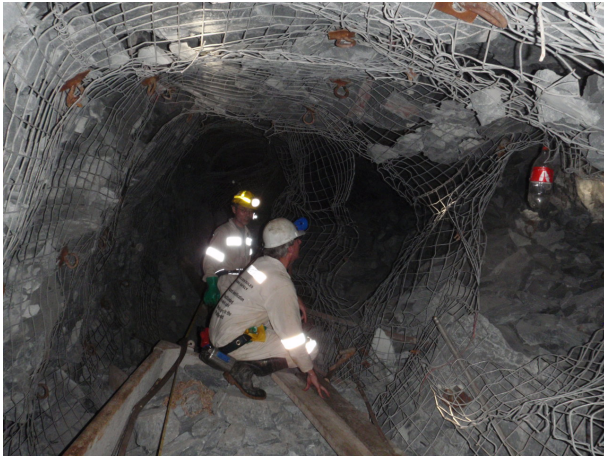
Photo. The M1.5 seismic damage at a pilot tunnel at 104L at Tau Tona, at the closest proximity of which the BX CCBO in-situ stress measurement was carried out. Harumi Kato and Gerhard Hofmann look at a potential rupture plane on the side wall. Photo by Hiroshi Ogasawara.

In-situ stress measurements were successfully carried out in close proximity to a M1.5 damaging seismic event at 104 level (about 2950 m depth) at Tau Tona gold mine in South Africa. This event occurred on 3 December 2012, and on the 6th and 7th of February 2013, three overcoring stress measurements were done. The seismic event took place almost at the end of a pilot tunnel (see a photo attached), and significant dynamic rock mass ejection from the sidewall of the tunnel occurred. Elastic numerical modelling did not indicate any anomalous stress levels, but due to the severity of the damage it was important to better understand prevailing stress conditions. Stress measurement methods commonly used in South Africa (e.g. CSIR triaxial cell method or CSIRO HI method) was not suitable for such high stress conditions or adverse drilling conditions.

No in-situ stress measurements have been carried out close to the area of the damaging seismic event before, and hence no stress information was available towards mitigating seismic risk. It was proven that the BX CCBO technique can be implemented in adverse underground conditions - high stress and limited shift working hours in the South African gold mines. We hope that stress measurement can be done regularly together with a pilot geological drilling program, prior to advancing the pilot tunnel, which will fundamentally contribute to mitigate seismic risk in South African gold mines.
