## Significant issues posed by the 2016 Kumamoto earthquake with regard to active fault assessment and disaster mitigation

# Building Damage on Surface Faulting of 2016 Kumamoto Earthquake, and Counter Measures

# Geotechnical aspect of damage found along seismic fault that appeared in the 2016 Kumamoto Earthquake

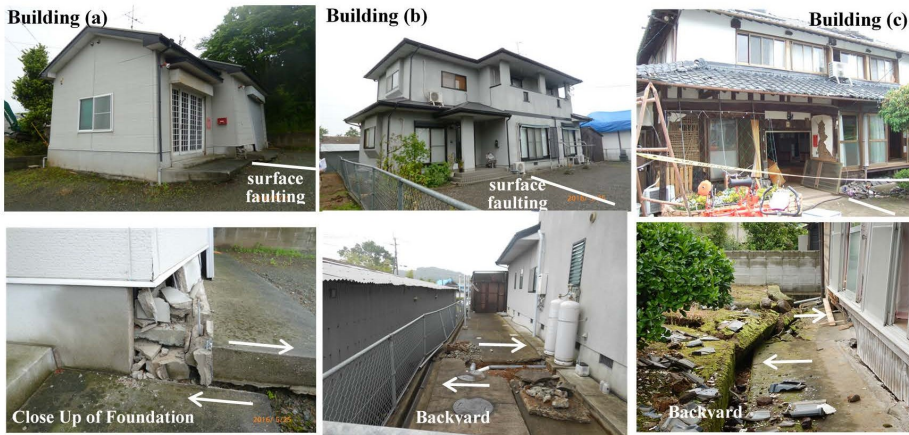
写真 1 御船町高木地区における地表地震断層直上の建物被害の例

(1) 古い在来木造住宅 (2) 新しい軽量鉄骨住宅 (3) 非常に古い伝統木造住宅

This paper reports the results for investigating building damage near the surface faulting of the 2016 Kumamoto earthquake, and counter measures of building. The results of the building investigation indicated that most of severe damage occurred in those directly above the surface faulting, because of its slip deformation. And, almost all severe damaged buildings were very old wooden houses/apartments, whereas new wooden or RC buildings showed very minor damage. In the Shimojin area, for examples, the ground motion was probably not strong enough to cause severe damage, and thus, the highest damage was Grade 3. All of them were very old wooden buildings and directly above the surface faulting. Even though the best counter measure for buildings near active faults is to avoid them, it is unrealistic to prohibit regular buildings in such areas shown in this study, because the exact locations of the surface faulting are very difficult to identify. In fact, they differed from those of the actual surface faulting, because of the young alluvial/volcanic sediments and the artificial land development. In addition, the recurrence intervals of the active faults are extremely long (usually several thousand years), as compared with the lifetime of a building. And the most importantly, various safety counter measures are effective, even for the building directly above the surface faulting. For example, the new wooden houses with the mat foundation of RC could prevent the slip deformation from reaching the building, and the combinations of the shear wall and light roofs prevented severe damage. On the other hand, the old Japanese traditional houses generally suffered severe damage, but their structural flexibilities could prevent collapsing by following the slip deformation. The collapsed buildings were generally very old and lacked both the sufficient earthquake-resisting structural members and the effective connections among them.

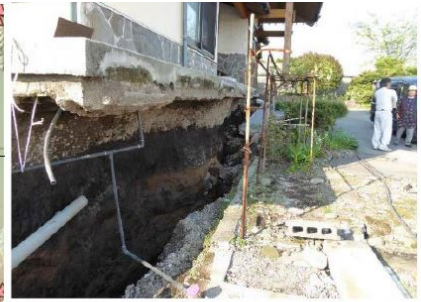
House hanging a little over the northwestern offset of the ground at N32.9568°, E131.0368

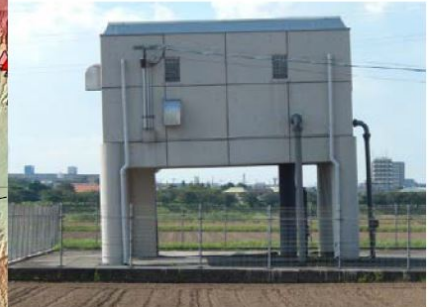
Tilted RC housing of pump for Akita clean water well No. 2 at N32.7670°, E130.7786 °: A low lying area east of this housing is found sunken by more than a meter

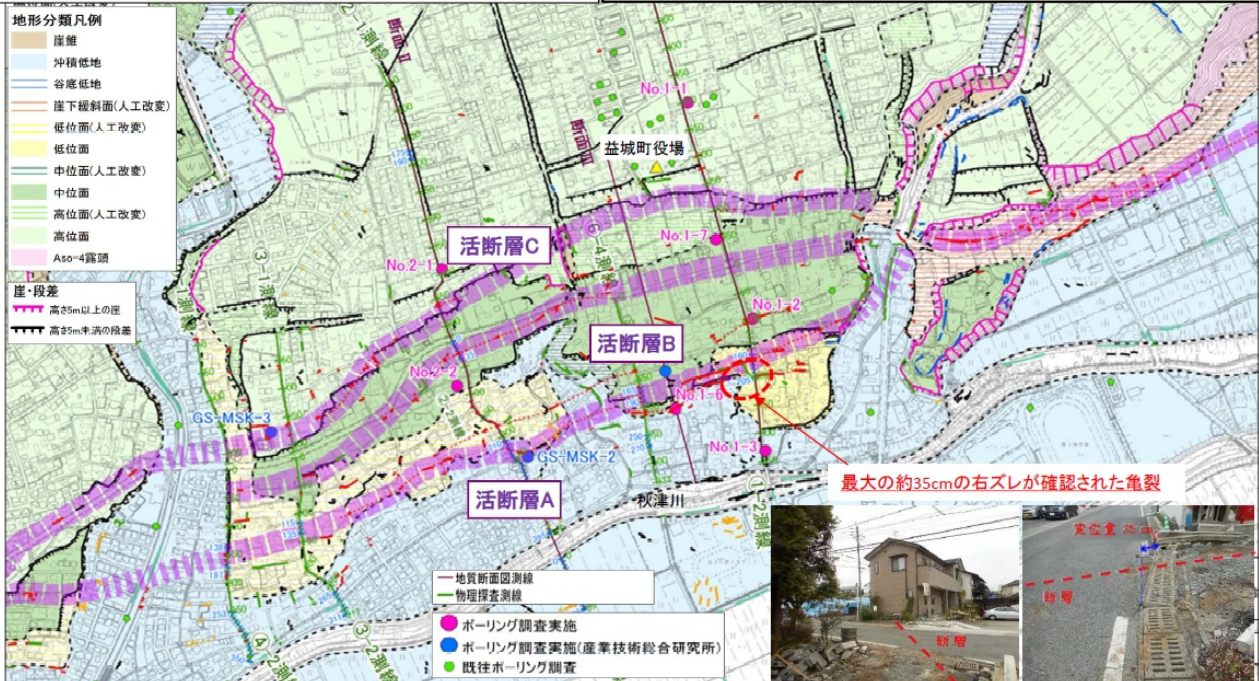
## 益城町市街地内における活断層の位置

以下の4点から総合的に判断

- ①同一地層の標高差の有無
- ②明瞭な段差地形の有無
- ③活断層の繰り返しにより柔らかくなった地盤の有無
- ④地表に現れる連続的な亀裂の有無

- 益城町市街地において、3本の活断層(A・B・C)が存在。
- 今回の地震では、**活断層Aが主体に活動し、益城町市街地では、最大35cmの右ズレ及び最大15cm程度の上下変位(南落ち)を確認。**  
(活断層B,Cのズレは活断層Aに比べて微量)
