## Significant issues posed by the 2016 Kumamoto earthquake with regard to active fault assessment and disaster mitigation

# Building Damage on Surface Faulting of 2016 Kumamoto Earthquake, and Counter Measures

This paper reports the results for investigating building damage near the surface faulting of the 2016 Kumamoto earthquake, and counter measures of building. The results of the building investigation indicated that most of severe damage occurred in those directly above the surface faulting, because of its slip deformation. And, almost all severe damaged buildings were very old wooden houses/apartments, whereas new wooden or RC buildings showed very minor damage. In the Shimojin area, for examples, the ground motion was probably not strong enough to cause severe damage, and thus, the highest damage was Grade 3. All of them were very old wooden buildings and directly above the surface faulting. Even though the best counter measure for buildings near active faults is to avoid them, it is unrealistic to prohibit regular buildings in such areas shown in this study, because the exact locations of the surface faulting are very difficult to identify. In fact, they differed from th

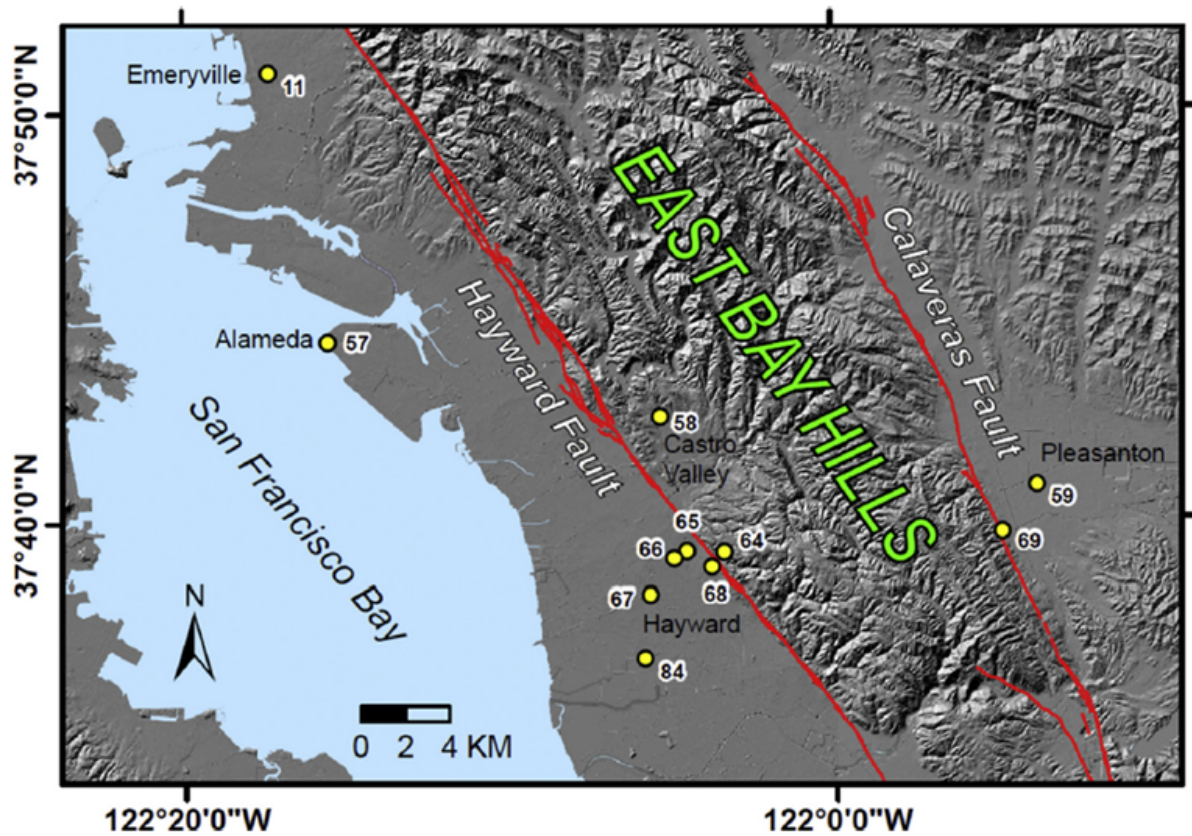
Figure 1. Sites of investigation. 11 : Emeryville, 57 : Alameda, 58 : Castro Valley, 59 : Pleasanton, 64 : CSU East Bay, 65 : Charles Ave, 66 : Huntwood Ave, 67 : Southgate Park, 68 : Cemetery, 69 : Alviso Adobe, 84 : Eden Shores Park.

We measured S-wave velocity ( $V_s$ ) profiles at eleven sites in the east San Francisco Bay area using surface wave methods. The sites were placed around the Hayward fault and the Calaveras fault (Figure 1). The 30-year probabilities of magnitude 6.7 or greater earthquakes on the Hayward-Rodgers Creek and Calaveras faults have been estimated at 32 % and 25 %, respectively. These faults run through densely populated areas and knowledge of a detailed two- or three dimensional  $V_s$  structure along the faults is needed in order to estimate local site effects due to a potential earthquake. This presentation summarizes data obtained by the surface wave methods, shows  $V_s$  profiles calculated by inversion, and discusses the effect of 2D  $V_s$  structure on surface ground motion. Data acquisition included multichannel analysis of surface waves using an active source (MASW), a passive surface-wave method using a linear array of geophones (Linear-MAM), and a two station spatial autocorrelation method (2ST-SPAC) using long-period accelerometers. Maximum distance between stations ranged from several hundred meters to several kilometers, depending on the site. Minimum frequency ranged from 0.2 to 2 Hz, depending on the site, corresponding to maximum wavelengths of 10 to 1 km. Phase velocities obtained from three methods were combined into a single dispersion curve for each site. A nonlinear inversion was used to estimate  $V_s$  profiles to a depth of 200 to 2000 m, depending on the site. Resultant  $V_s$  profiles show significant differences among the sites (Figure 2). On the west side of the Hayward fault and the east side of the Calaveras fault, there is a low velocity layer at the surface, with  $V_s$  less than 700 m/s, to a depth of approximately 100 m. A thick intermediate velocity layer with  $V_s$  ranging from 700 to 1500 m/s lies beneath the low velocity layer. Bedrock with  $V_s$  greater than 1500 m/s was measured at depths greater than approximately 1700 m. Between the Hayward Fault and the Calaveras Fault, thicknesses of the low velocity layer and the intermediate velocity layer are less than 50 m and 200 m respectively, and depth to bedrock is less than 250 m. To evaluate the effect of a lateral change in bedrock depth on surface ground motion due to an earthquake, a representative  $V_s$  cross section perpendicular to the Hayward fault was constructed and theoretical amplification was calculated using a viscoelastic finite-difference method. Calculation results show that the low frequency (0.5 to 5 Hz) component of ground motion is locally amplified on the west side of the Hayward fault because of the effect of two-dimensional structure. The results of this investigation indicate that the phase velocity information obtained using the 2ST-SPAC method with a limited number of high quality sensors provides valuable  $V_s$  information over a wide depth range. It offers a robust alternative to widely-used single station methods such as the horizontal to vertical spectral ratio. Though the 2ST-SPAC method and other passive surface wave methods using an anisotropic or linear array cannot equal the performance of an isotropic array in the case of strongly anisotropic ambient noise, they do provide an effective alternative for many urban environments where ambient noise is relatively isotropic and potential sites for array deployment are limited to corridors along roadways. The inversion of surface wave data is essentially non-unique and we cannot remove uncertainty from analyses, the effect of the uncertainty depends on the purpose of investigation and the use of the data. Several different velocity profiles that yield almost the same theoretical phase velocities were examined to evaluate the effect of uncertainty of inversion on amplification calculation. The results shows that the site amplifications calculated from  $V_s$  profiles are relatively insensitive to uncertainties in the velocity profiles.

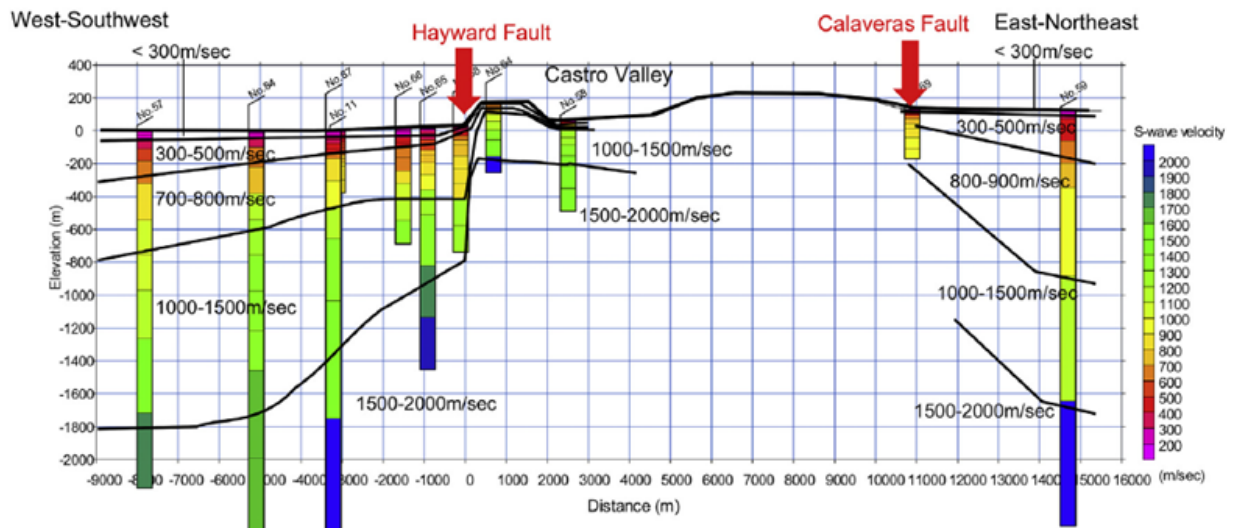
Figure 2. Schematic S-wave velocity section based on the S-wave velocity profiles obtained in this study.

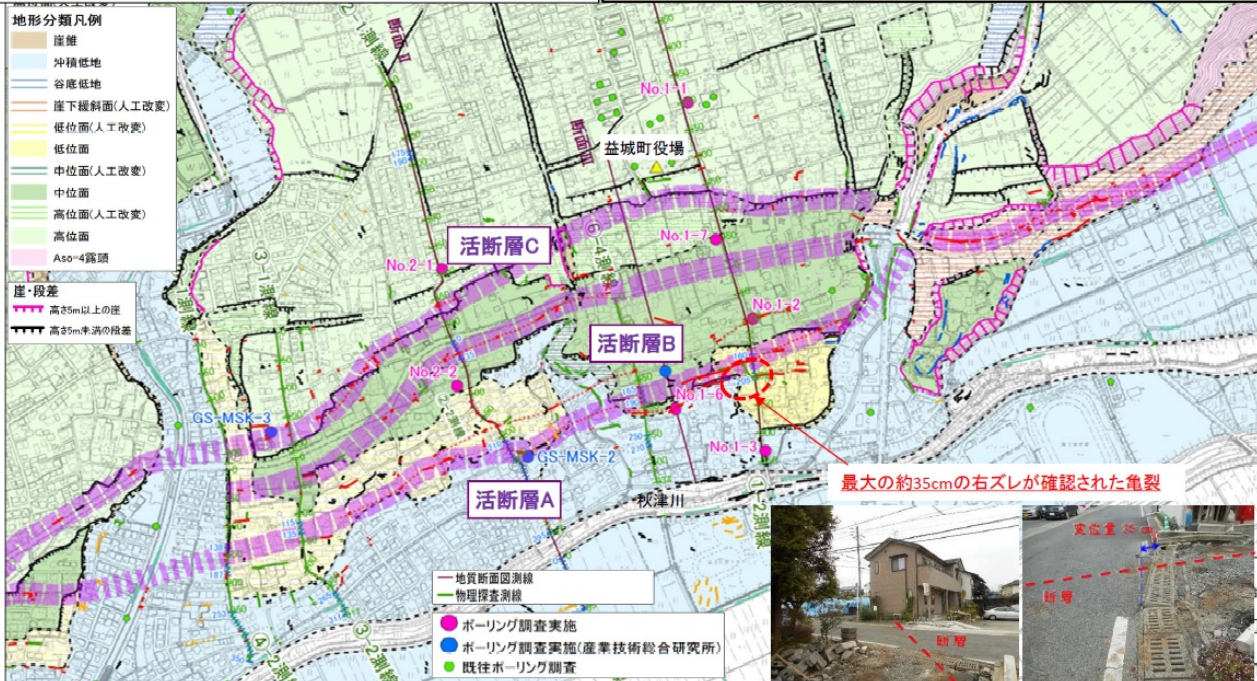
- 益城町市街地において、3本の活断層(A・B・C)が存在。
- 今回の地震では、**活断層Aが主体に活動し、益城町市街地では、最大35cmの右ズレ及び最大15cm程度の上下変位(南落ち)を確認。**  
(活断層B,Cのズレは活断層Aに比べて微量)

- ①同一地層の標高差の有無
- ②明瞭な段差地形の有無
- ③活断層の繰り返しにより柔らかくなった地盤の有無
- ④地表に現れる連続的な亀裂の有無

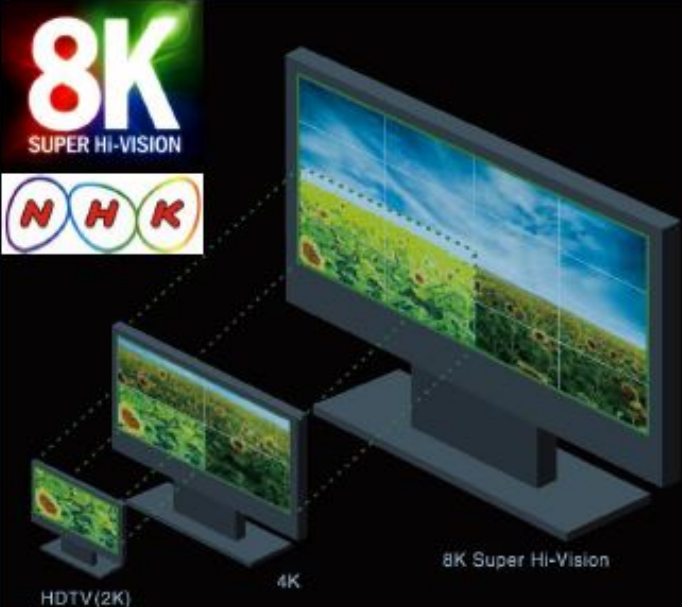
HDTV(2K)      4K      8K Super Hi-Vision

The 8K Super Hi-Vision system supports higher frame rates to enable vivid reproduction of the subject, in addition to ultra-high definition video of approximately 33 megapixels. Also, the wider color gamut and greater bit depth have made it an ultimate TV broadcasting system capable of reproducing bright colors more accurately.

Aspect ratio	16 : 9
Pixel number	7,680 × 4,320
Frame rate	120, 119.88, 60, 59.94 Hz Progressive
Scanning	Progressive
Bit depth	10, 12 bit
Color gamut	Wide gamut system colorimetry

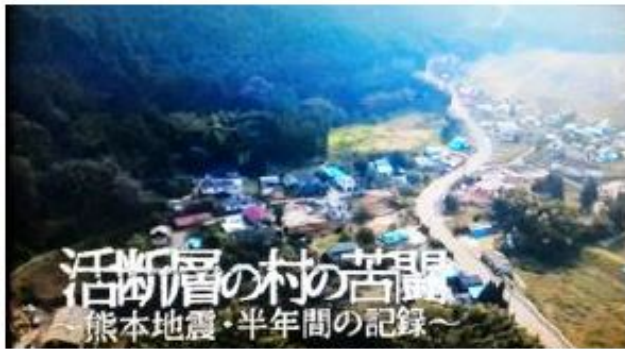
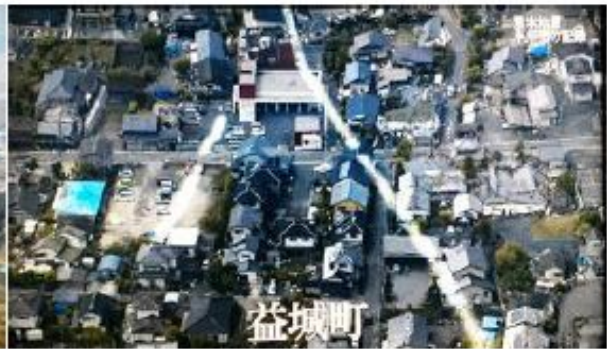
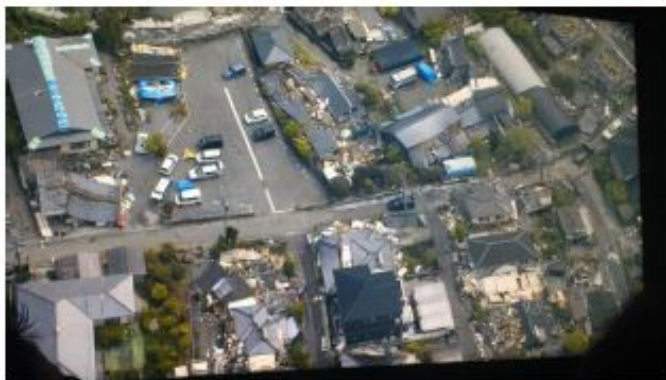
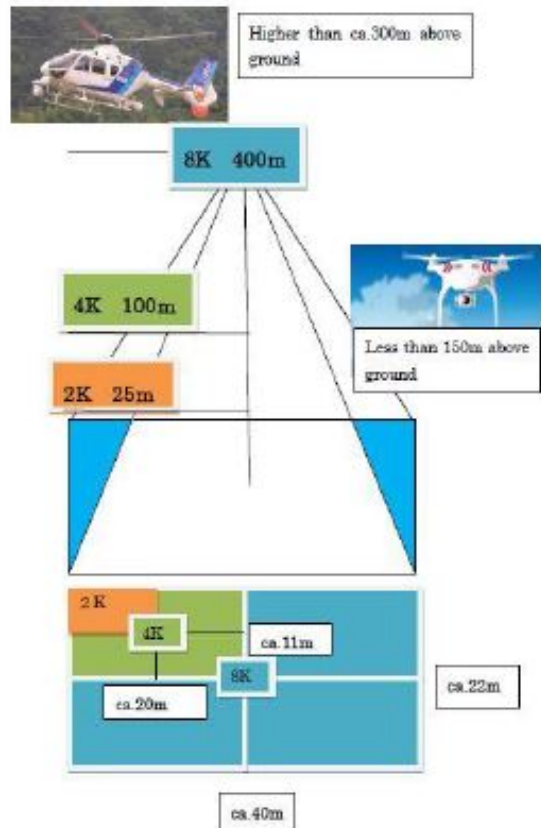
**resolution:** The ground pixel size  
**5 mm :** 8K (this study)  
**100 mm :** aerial photograph of Geospatial Information Authority of Japan

**You can watch flying butterfly on the ground shot by 8K camera from 400m high above ground.**

Aerial filming using an 8K camera enables discovery of ruptures as small as a few centimeters from an altitude of 400 meters, and provides "higher resolution" than aerial photography and "wider angles of view" than 4K drones. Since ruptures may cause a variety of disasters, there are high expectations for the utilization of 8K images in DRR. 8K images also allow the observation of each individual's "move," which will be effective for life-saving and search operations and detecting temporary shelters. 8K's "oblique bird's-eye views" provides vertical information that will make it easier to survey collapsed buildings, and its graphics data can be utilized for making "3D models" and "crisis maps."

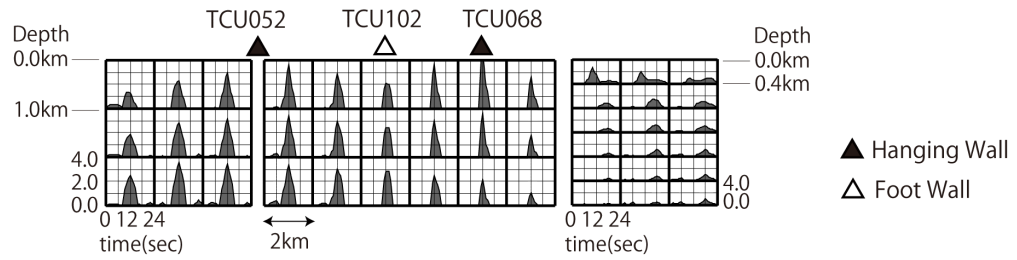
Figure 1. Slip velocity function by Wu et al.(2001) near strong-motion stations in the northern part of 1999Chi-Chi

Whereas, observation velocity waveforms of TCU052 lying on the foot wall has a different from slip velocity function. In addition, it cannot be said that subfaults close to strong-motion stations dominates in velocity waveforms. One reason for this is the greater are that displacement on the footwall is smaller than on the hanging wall because of low dip angle (about 30°). It was noted that it is difficult to approximate slip velocity function from only near-fault strong ground motions. Besides, it may be suspected that accuracy of slip velocity function is low if strong-motion stations lie only on the foot wall of low-angle fault. Incidentally, we estimated that the values for duration of triangle time window as slip velocity function and average slip of subfaults close to TCU102 were 6sec and 9.6m, respectively.

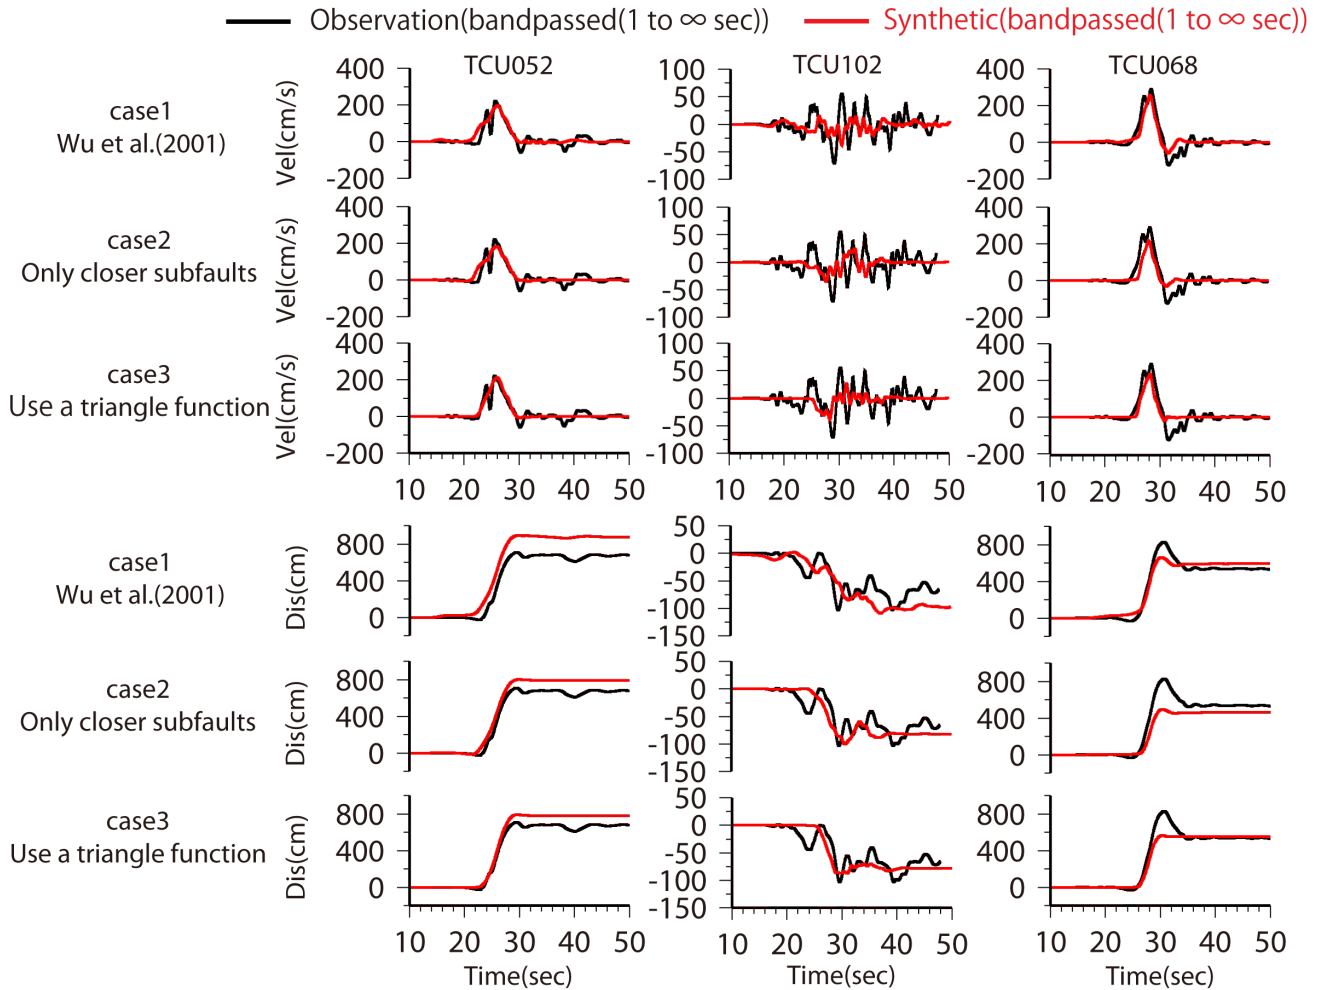
Figure 2. Comparison of synthetic and observation waveform fittings ( NS component, 1999Chi-Chi )

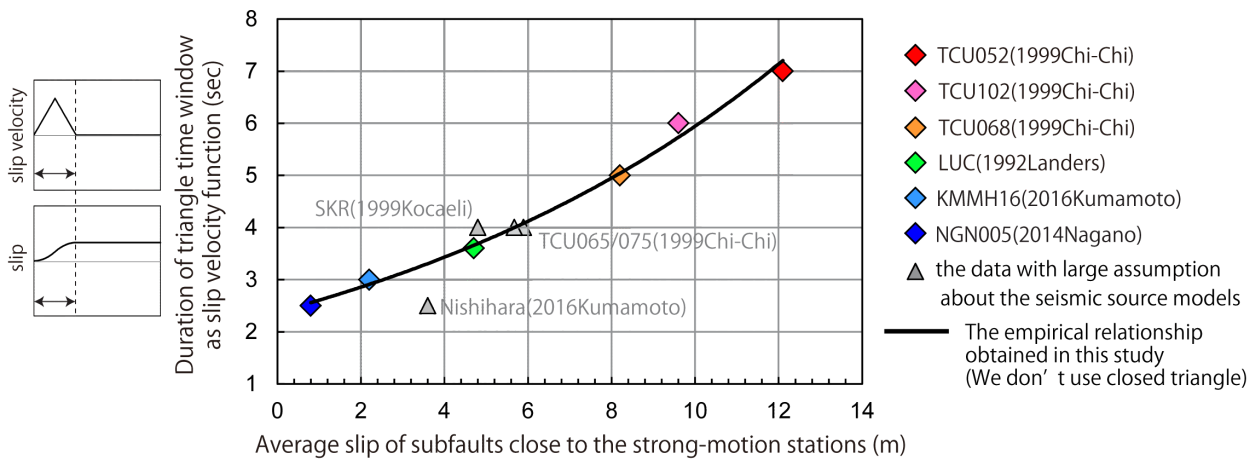
Figure 3. Relationships among slip velocity function and slip in shallower region than the seismogenic layer

In light of these considerations we estimated slip velocity function for the region shallower than seismogenic layer for other earthquakes in the same way as 1999 Chi-Chi earthquake. It was found that

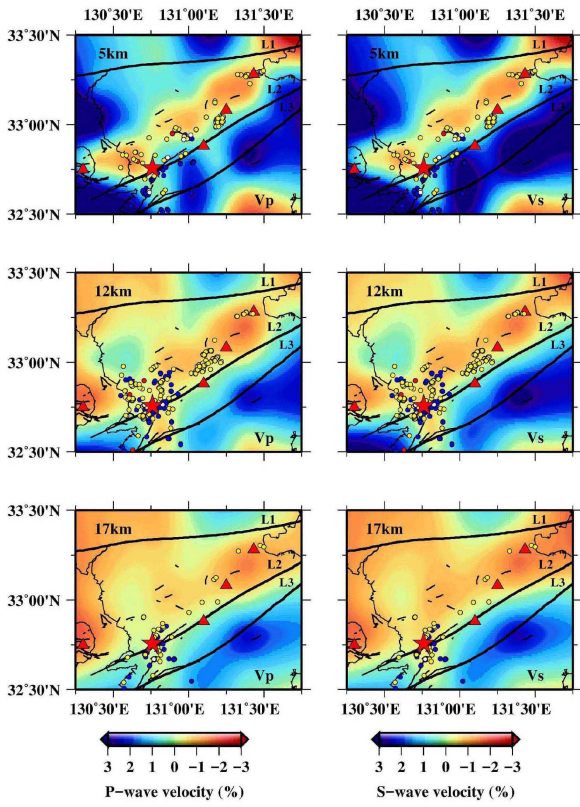
Figure 1:  $V_p$  and  $V_s$  anomalies at three depths of the upper crust
