## Close-range remote sensing for monitoring the weathering in wall surfaces of a historical building at Orval Abbey, Belgium

## 多視点ステレオ技術に基づく磨崖和靈石地蔵の劣化状況評価

### The degradation state of the Wareishi Rock Cliff Sculpture based on the multi-view stereo.

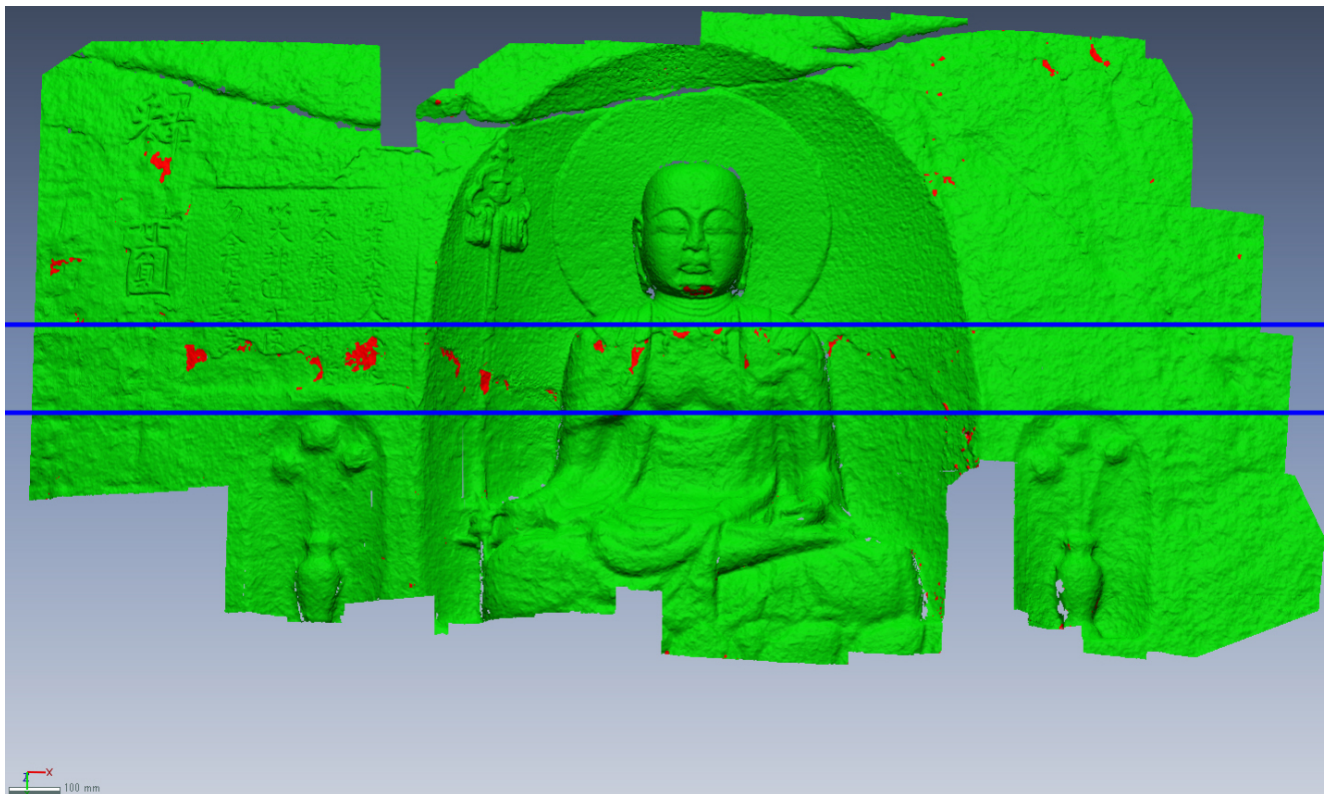
As a result, the difference between the shapes of the Sculpture and the replica was detected mainly on the middle part of the core stone constituting a horizontal belt of ca. 20 cm parallel to the sea level. The total area of the places where more than 3 mm difference was detected constitutes ca. 0.56 % of the whole measured area.

The upper surface of the beltlike deteriorated area almost concurs with that of the darkened area of the present Sculpture, whereas the lower surface of the deteriorated belt with the upper surface of the darkened area of the replica. In other word, the degradation of the Sculpture during these 30 years is detected mainly on the belt between the uppermost lines of algae on the Sculpture at present and at 30 years ago.
