日本のジオパークにおけるジオサイトの保全状況 Conservation state of geosites in Japanese geoparks

Methodology of 3D Measurement - Case Study in the Main Church of Sopocani Monastery, Southern Serbia -

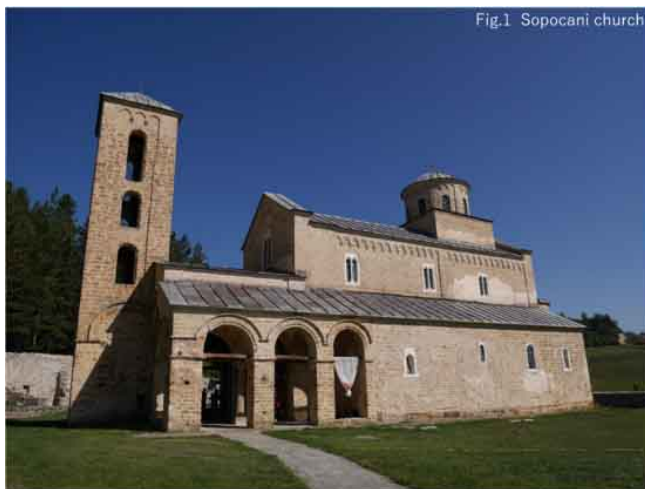
Fig.1 Sopocani church

This paper deals with the methodological challenges of 3D scanning of the main church of Sopocani Monastery (hereafter called Sopocani church)[Fig.1], the world cultural heritage in southern Serbia. Accurate documentation of the heritage is the fundamental basis of scientific analyses as well as its conservation. 3D scanning, with rapid development both in hardware and software during last decades, has been applied in the field of the heritage study with different range of accuracy and scale. In some cases, however, the requirement of survey and the delicacy of the heritage may cause particular difficulties, even though 3D scanning enables us to reach such part where measurement could not be carried out otherwise. This paper shows challenges of heritage scanning, taking Sopocani church an example of historical structure of stone. The scanning data of this church, threatened of decay, should constitute an effective base for the future conservation project.
