# Methodology of 3D Measurement - Case Study in the Main Church of Sopocani Monastery, Southern Serbia -

\*HIDAKA MIDORI<sup>1,2</sup>, Vojin NIKOLIC<sup>3</sup>

1. Tokyo University of the Arts, 2. Japan Society for the Promotion of Science, 3. Institute for the Protection of Cultural Monuments of Serbia

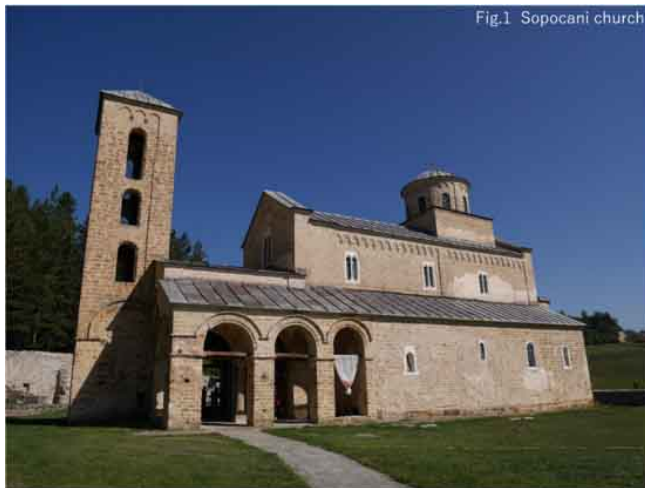
This paper deals with the methodological challenges of 3D scanning of the main church of Sopocani Monastery (hereafter called Sopocani church)[Fig.1], the world cultural heritage in southern Serbia. Accurate documentation of the heritage is the fundamental basis of scientific analyses as well as its conservation. 3D scanning, with rapid development both in hardware and software during last decades, has been applied in the field of the heritage study with different range of accuracy and scale.

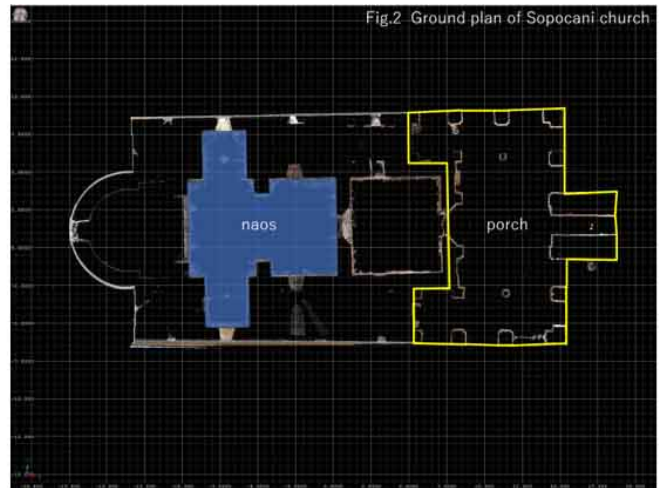
The laser scanning data indicate relatively small variation of the thickness of the wall of the church, 0.957-1.001m, which may prove the quality of the original construction[Fig.2]. Regarding the porch, added later, there is a difference of 0.784m in width. Columns of the porch show outward inclinations, being 7 degree at the most[Fig.3]. If such inclinations, already confirmed by the author in old photographs as well, should be monitored together with the deformation of the arches, the scanning data are of fundamental importance. The data clearly indicate the difference of building quality between the original and later extension.

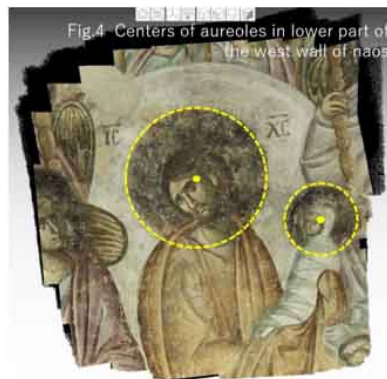
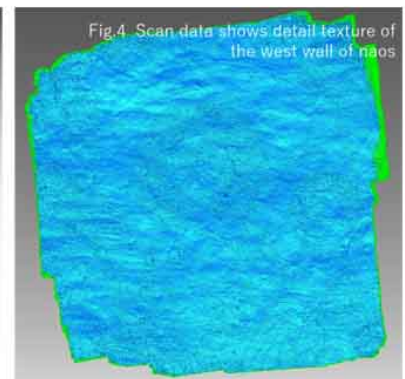
LED scanning data have shown certain hidden painting technique and characteristic depiction of the west wall of naos (12.811×6.323m), where saints and angels are painted[Fig.4]. Analysis of scan data has revealed that position of the aureoles of saints is different in lower and upper part of the painting. In lower part, centers of aureoles are placed around the temple, while they are placed around the forehead in higher part. The faces are slightly longer in upper part. We may presume that painters adopted this technical device as they were conscious of the figures to be looked up by people standing on the ground floor. LED scanning also clarified unique depiction in Sopocani church: fine grid pattern is obvious on the
