Mechanism of occurrence of "Ikenotaira"-pond appear from time to time in the Misakubo town, Shizuoka Prefecture

TAKAHASHI, Yukaya^{1*}, KONO, Tadashi²

¹Graduate School of Geo-environmental Science,Rissho University, ²Faculty of Geo-environmental Science,Rissho University

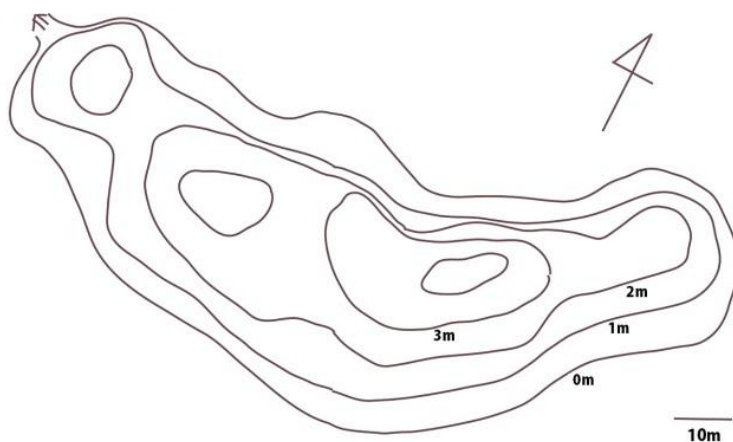
As a result of the lake basin survey near the 654 m above sea level and showing a depth contour, the maximum length of this pond is 130m, the maximum breadth of 50m, the circumferences is 130m, the area is 4325m², and the capacity is 11375m³.
