Relationships between building damage and characteristics of strong ground motions during the M6.5 Zhaotong Earthquake-I

WANG, Xin^{1*} ; MA, Qiang² ; SI, Hongjun³ ; DANG, Ji⁴ ; WU, Hao⁵ ; KURAHASHI, Susumu⁶

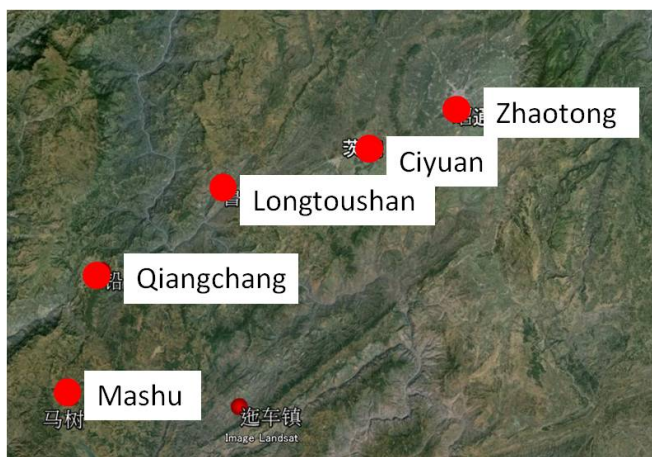
In order to make clear the building damage condition and the ground amplitude and period characteristics, we performed the onsite investigation of building damage and the microtremor measurement from November 9th ~12th, 2014. The places which have been investigated are marked with red dots in Fig 1. The PGA of investigated places are, 15 gal at Zhaotong city, 45 gal at Ciyuan town, 137 gal at Qianchang, and 135 gal at Mashu town. Based on the attenuation relations of PGA, it has been known that the accelerations attenuated fast with the increasing of fault shortest distance.
